Testing of Joramark BOX300 according to ETAG 022 Annex F

Task **Testing of Joramark BOX300 according to ETAG 022 Annex F**

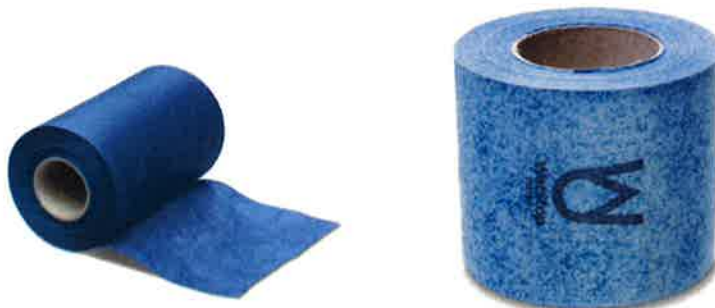
Picture 1. The waterproofing reinforcement tapes used in the tests.

Performance of the task Four gypsum boards size of 550x600 mm were primed with Casco Primer. The BOX300-hatches were attached in the holes in the centre of the test boards. The edges of the BOX300 hatches were cleaned, grinded and sealed with Casco waterproofing reinforcement tapes (picture 1). Two layers of Casco waterproofing membrane were applied.

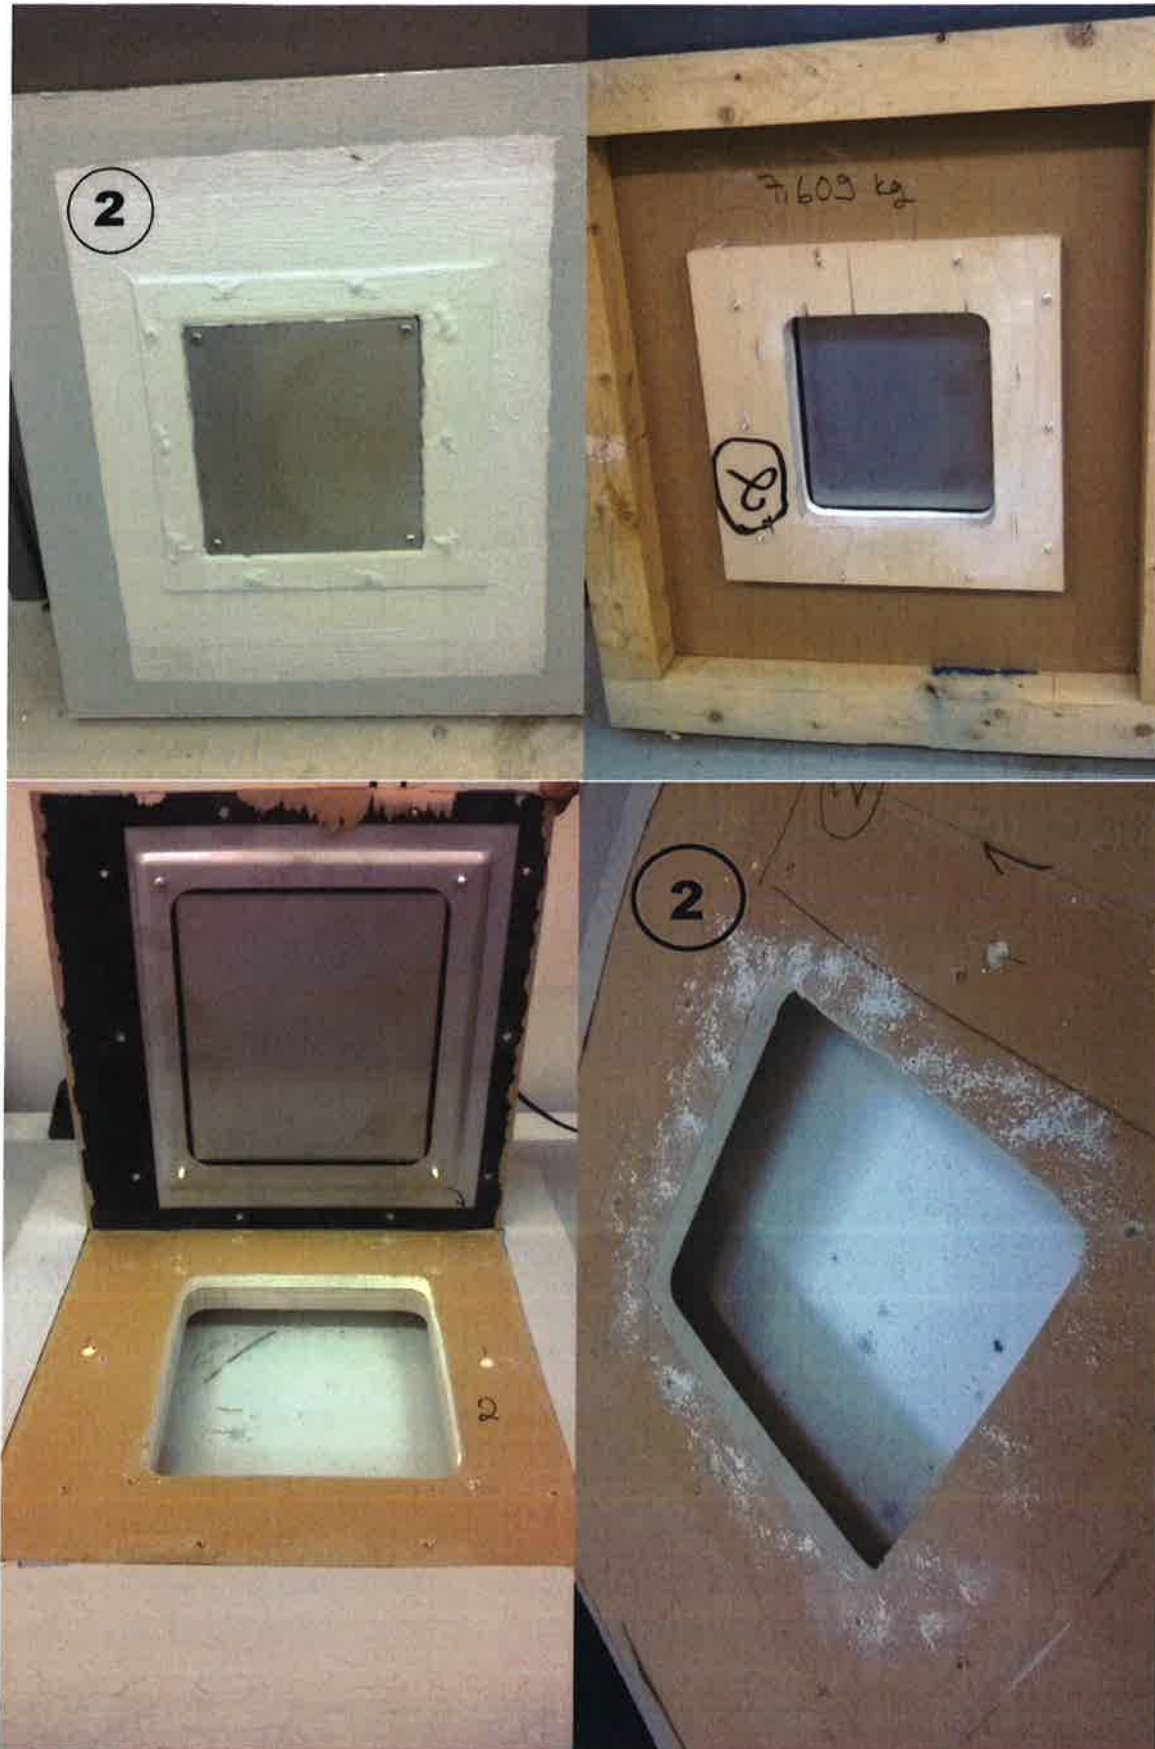
Picture 2. Test specimen no. 2 after testing.

Product / Structure	Wet consumption	Result
BOX300 + Casco Waterproofing tape 3647	<u>Specimen 1</u> Primer 88 g/m ² Waterproofing 1675 g/m ²	ETAG 022 Annex F, Watertight
	<u>Specimen 2</u> Primer 79 g/m ² Waterproofing 1717 g/m ²	ETAG 022 Annex F, Watertight
BOX300 + Casco Wetstop KL-tape 3798	<u>Specimen 3</u> Primer 77 g/m ² Waterproofing 1838 g/m ²	ETAG 022 Annex F, Watertight
	<u>Specimen 4</u> Primer 75 g/m ² Waterproofing 1879 g/m ²	ETAG 022 Annex F, Watertight

Specimen no.	Under the edge of the reinforcement tape	Under the waterproofing membrane
1	0.3 %	0.3 %
2	0.3 %	0.3 %
3	0.3 %	0.3 %
4	0.3 %	0.3 %

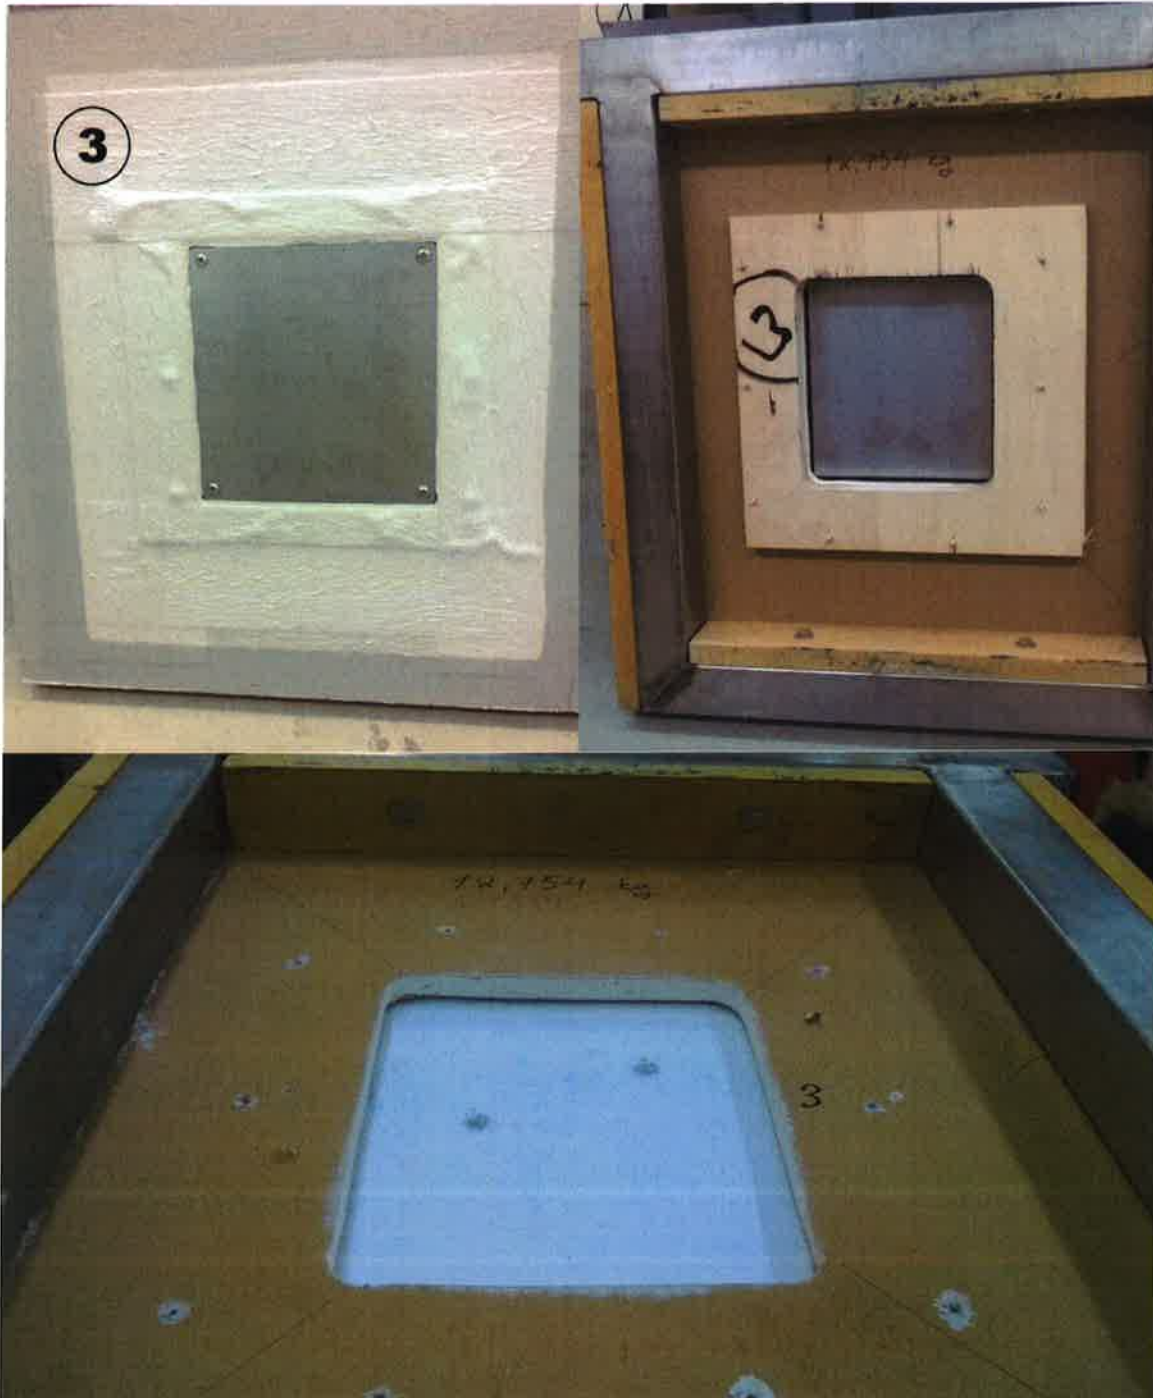
Picture 3. Test specimen no. 3 after testing.

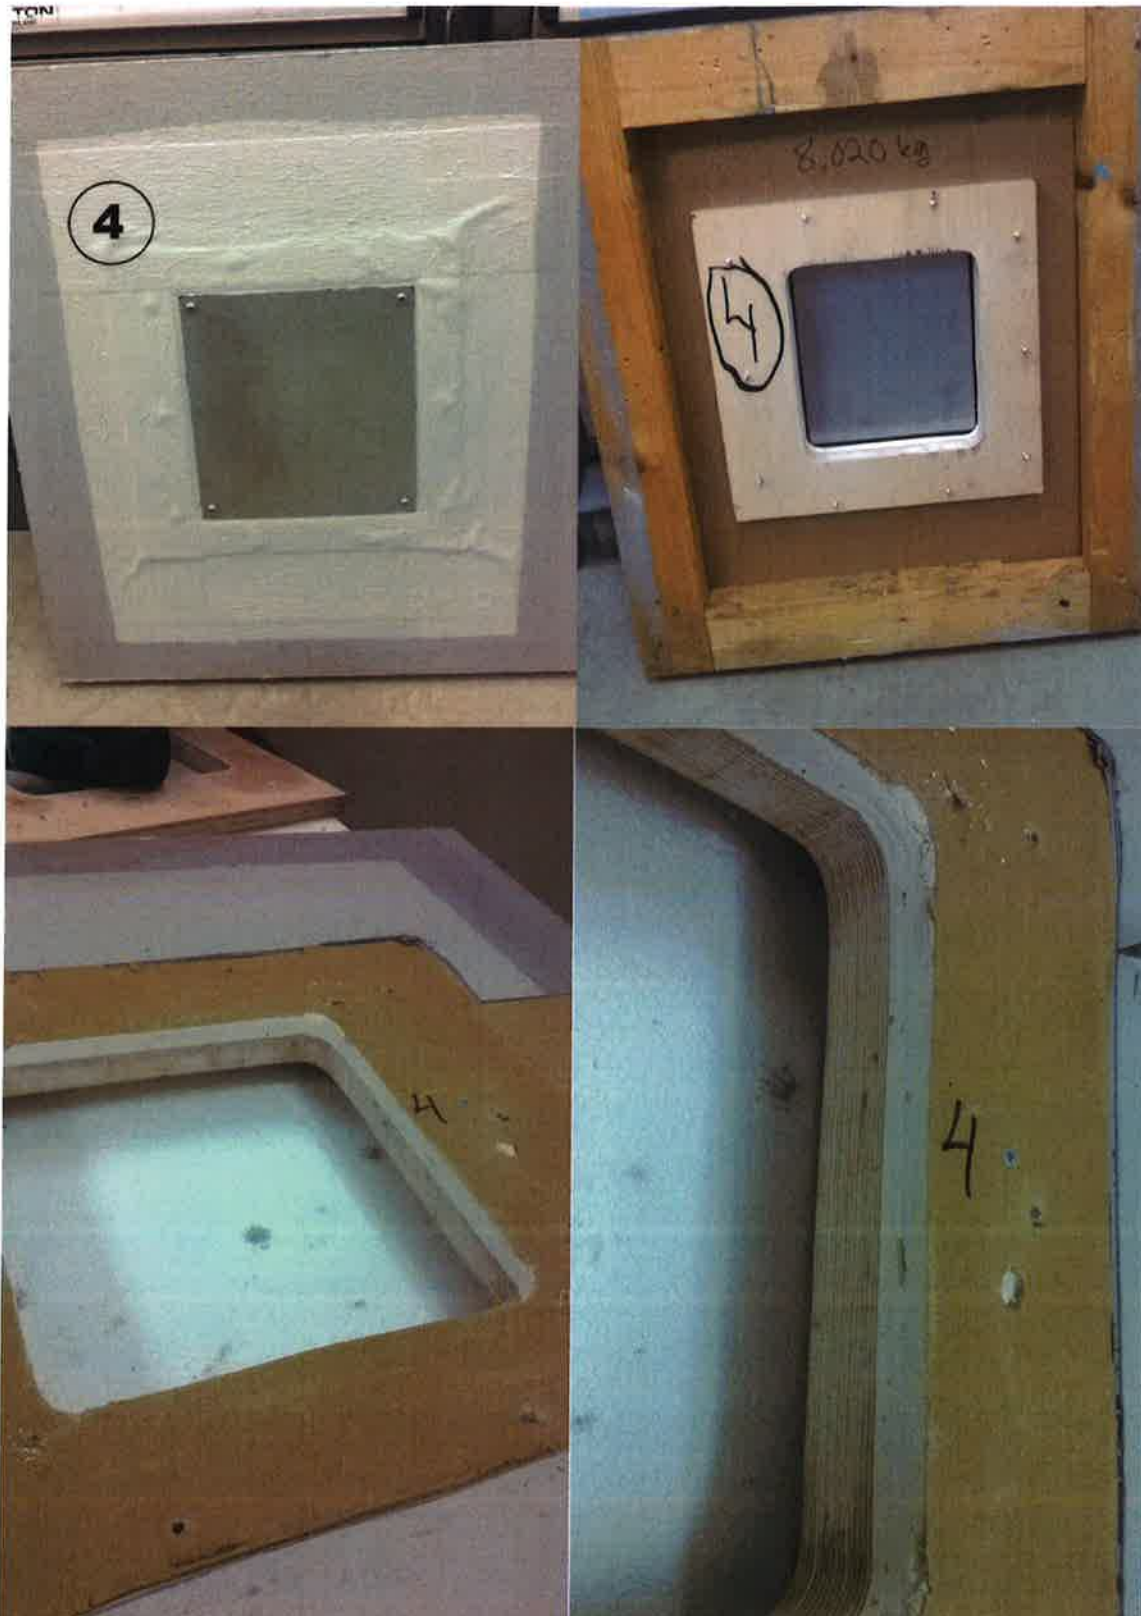
Picture 4. Test specimen no. 4 after testing.
